UNIVERSITY
of DAYTON
RESEARCH
INSTITUTE

NAVY HIGH-STRENGTH STEEL CORROSION-FATIGUE MODELING PROGRAM

October 2006

1. REPORT DATE OCT 2006		2. REPORT TYPE Technical Report		3. DATES COVERED 30-06-2003 to 31-08-2006	
4. TITLE AND SUBTITLE Navy High-Strength Steel Corrosion-Fatigue Modeling Program			5a. CONTRACT NUMBER F42620-00-D-0039, 0011		
			5b. GRANT NUMBER		
			5c. PROGRAM ELEMENT NUMBER

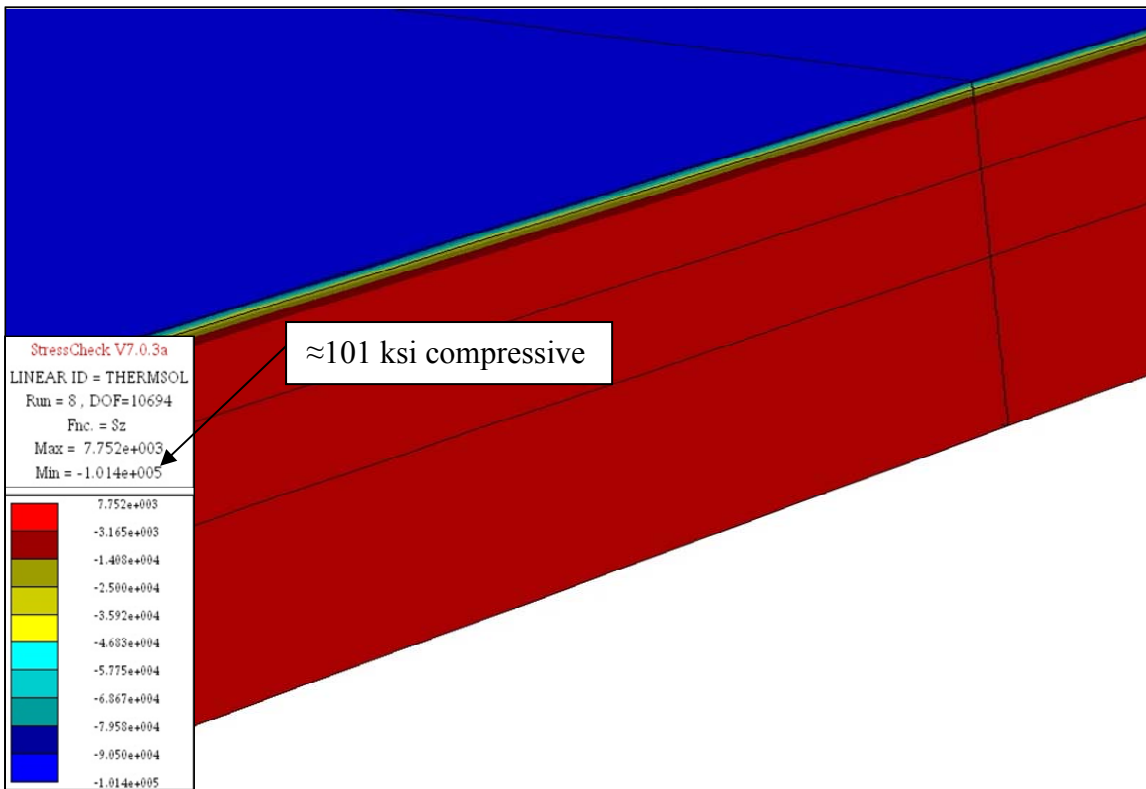
Figure 25. Induced Residual Stresses by Thermal Loading on a Pristine Quarter Specimen

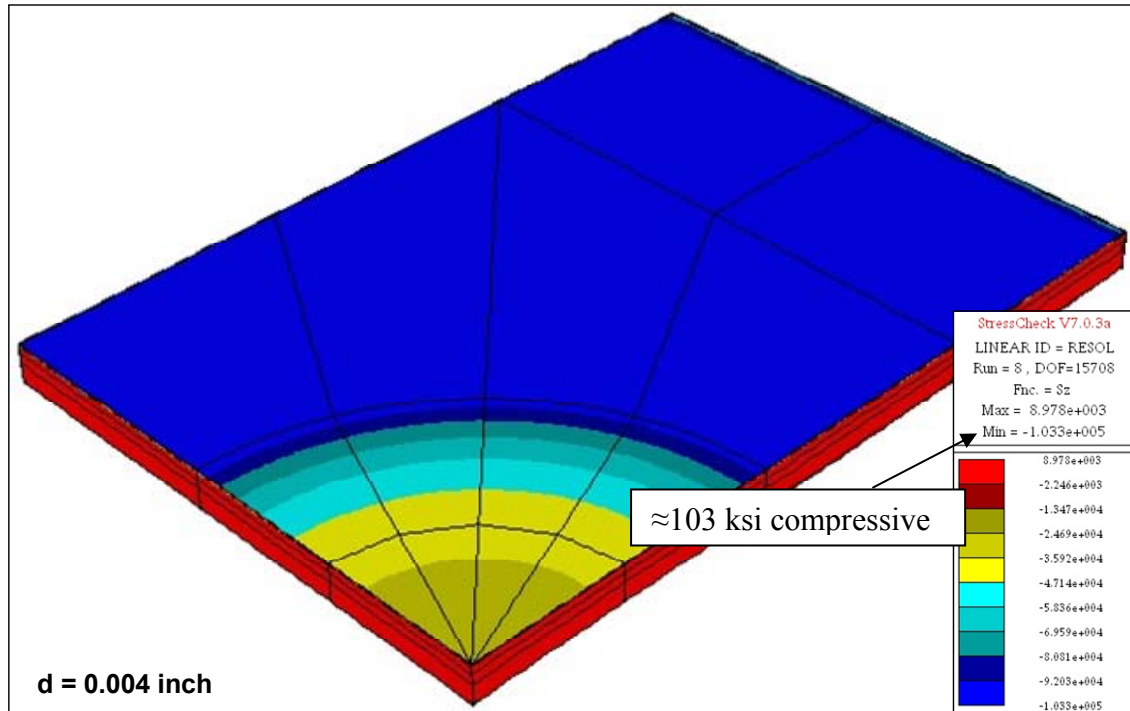
Figure 26. Induced Residual Stresses by Thermal Loading on a Grindout Quarter Specimen

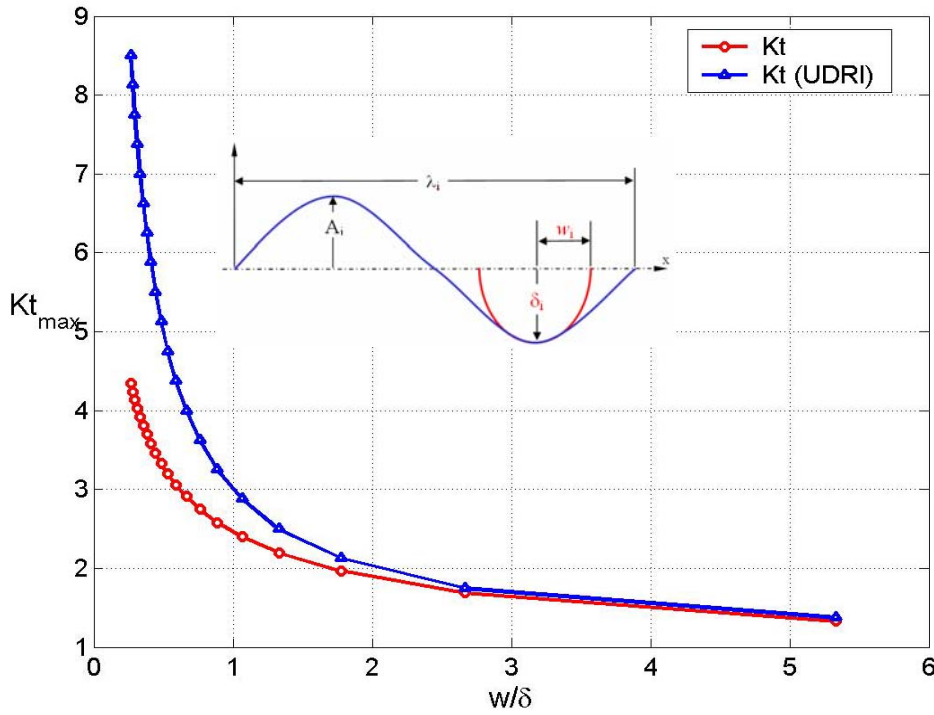
Figure 36. Case 1 Comparison of Exact Kt vs. Pit Metric Kt_{app} for Variable Pit Width

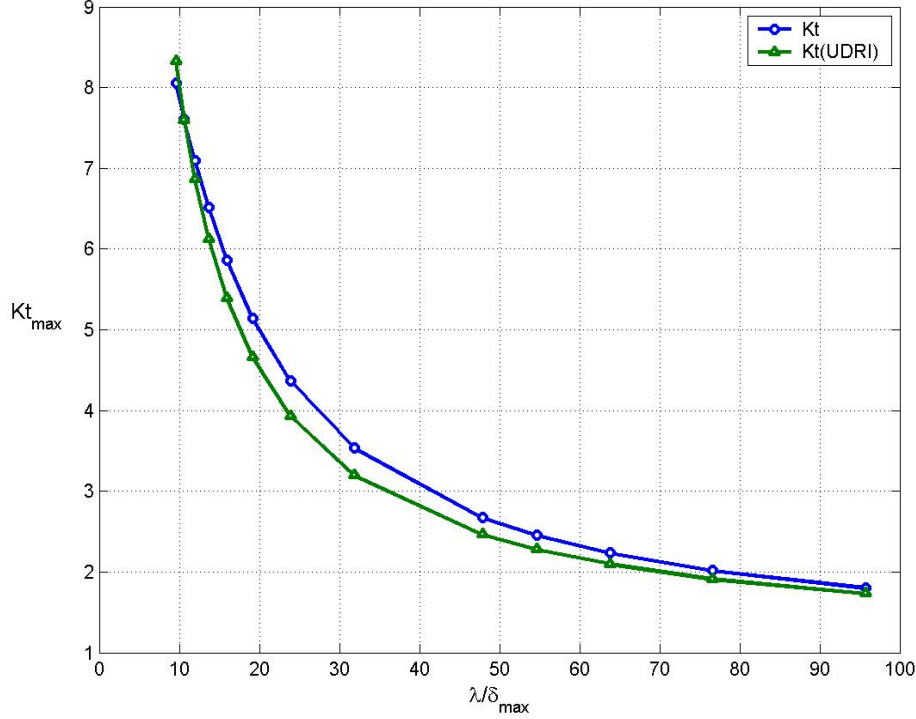
Figure 40. Case 2 Exact Kt vs. Pit Metric Kt_{app} for Variable Wavelength

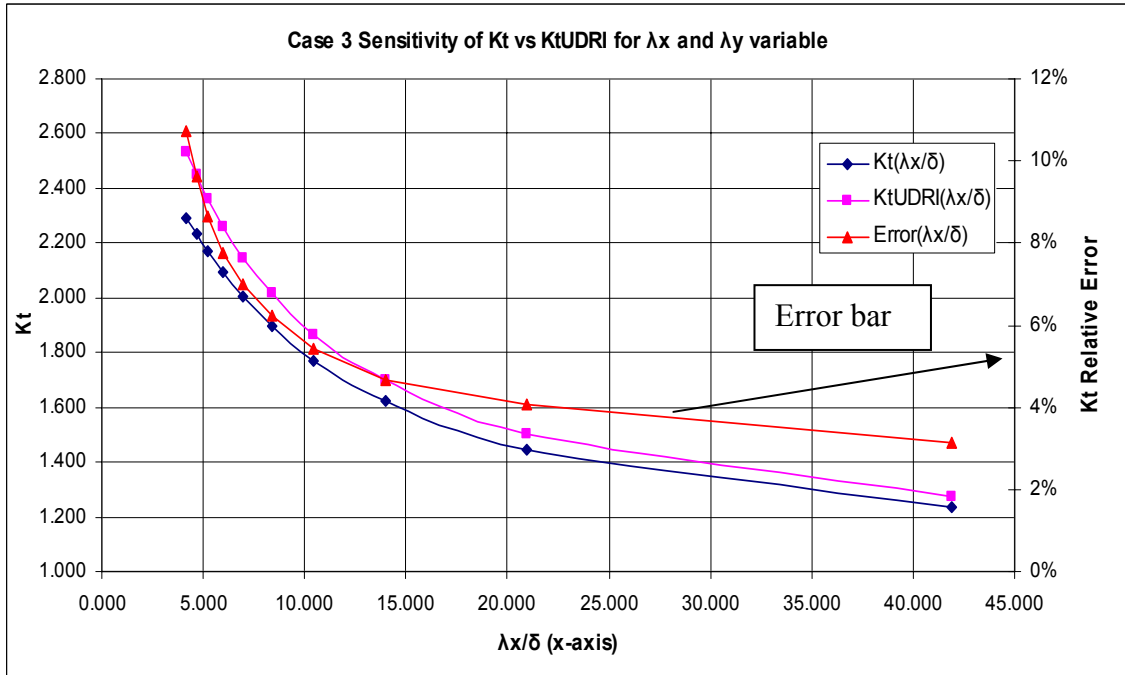
Figure 46. Case 3: Exact Kt vs. Pit Metric Kt_{app} for Variable λ_x

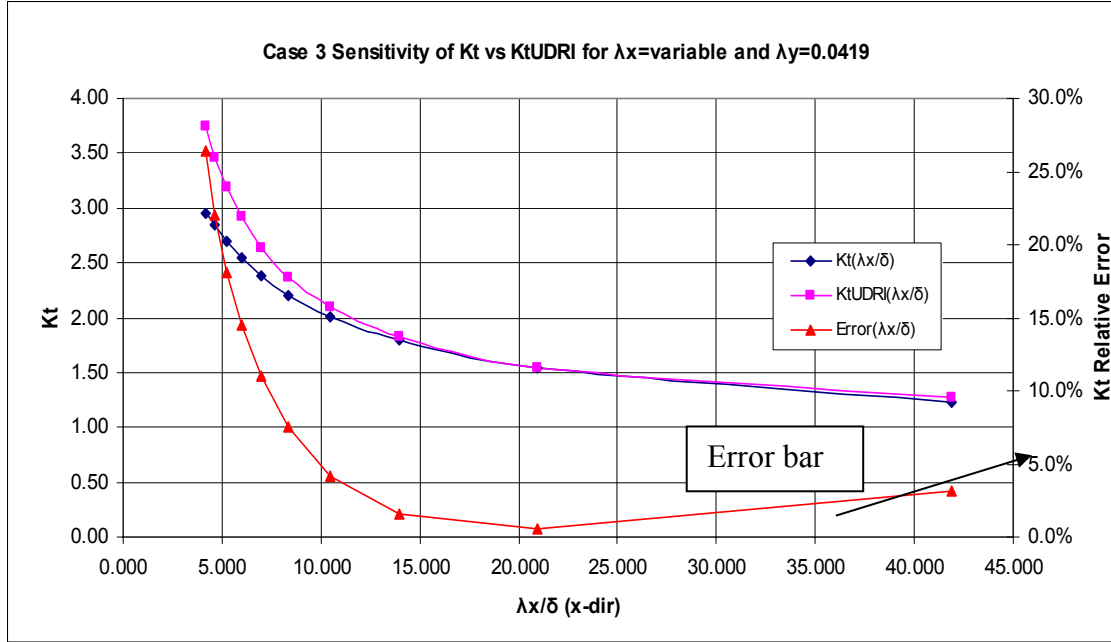
Figure 48. Case 3: Exact K_t vs. Pit Metric K_{tapp} for Variables λ_x and λ_y

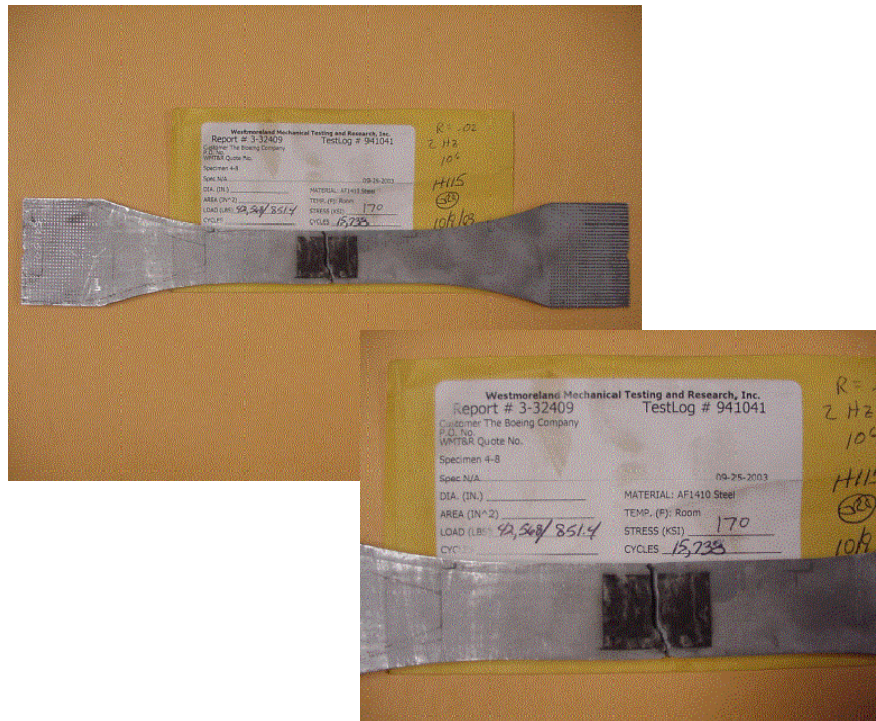
Figure 4-9 .Specimen 4-8 Fracture Surface Showing Fatigue Origins and Fracture Dimensions

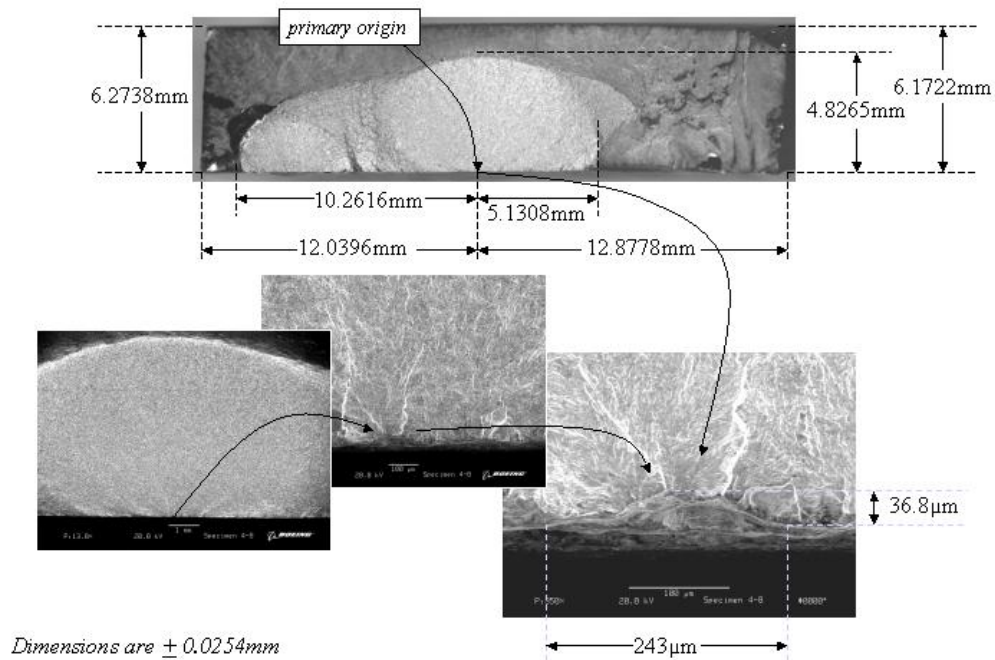
Collages of pictures are provided in Figure 4-10 to better describe the failure characteristics. At the top center is the fracture surface with the next picture being a side view of the specimen. The lines of corrosion demarcation can be seen on side and at the bottom of the test sample.

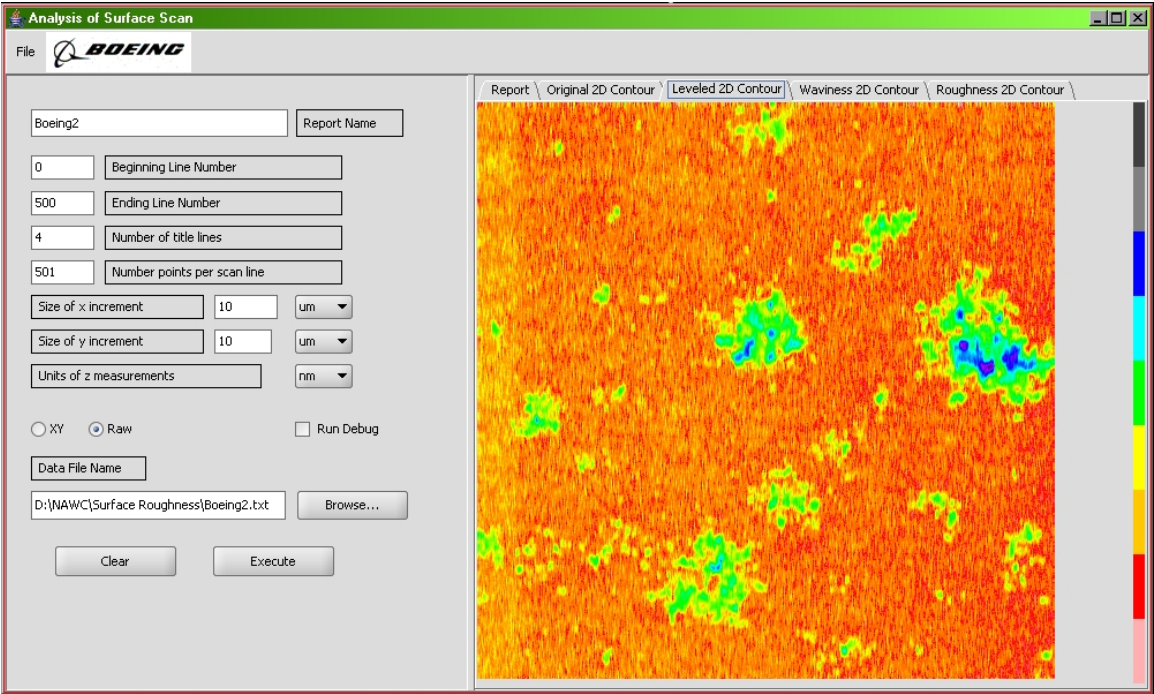
Figure 11-5 Filtered Profile

The profilometry file is processed to determine the waviness and roughness components of the surface. This is accomplished using a 0.8mm cutoff wavelength Gaussian filter. The standard suite of roughness parameters, (see Section 3 for a discussion of these parameters), for the resulting surfaces is computed and displayed in a text report. In addition to two dimensional views of the various surfaces, a three dimensional view is generated that can be rotated to allow a unique perspective to be obtained on the nature of the surface being analyzed.

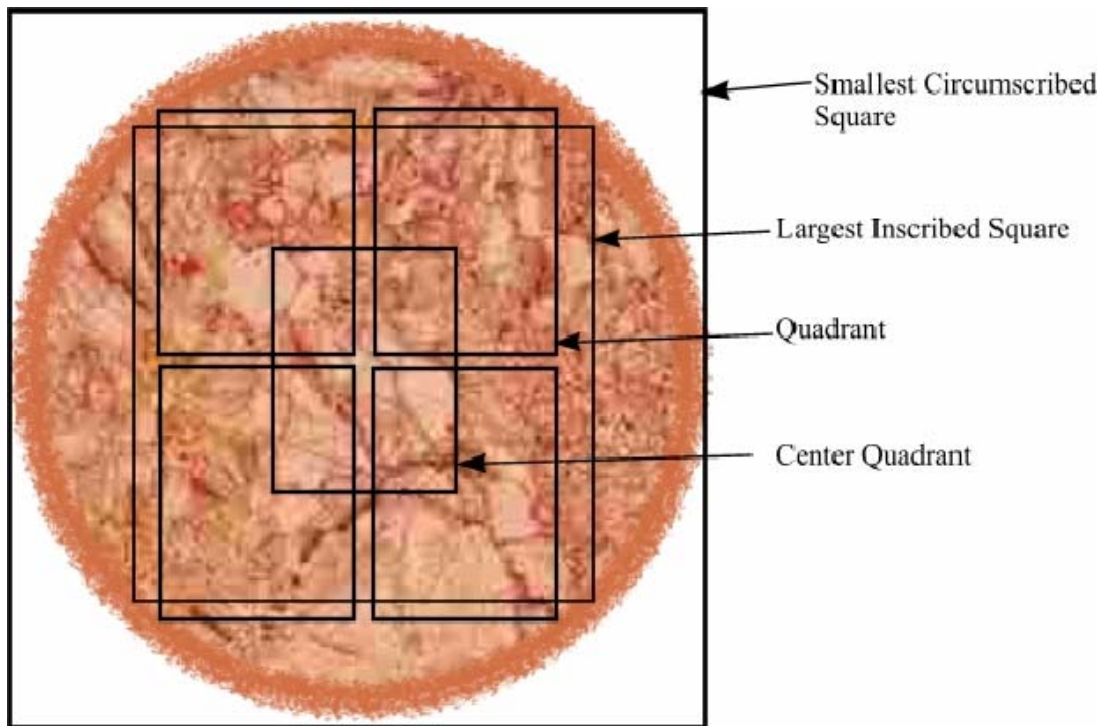
Figure 12-2 Detail of Corrosion Spot Showing Areas Used in Roughness Analysis

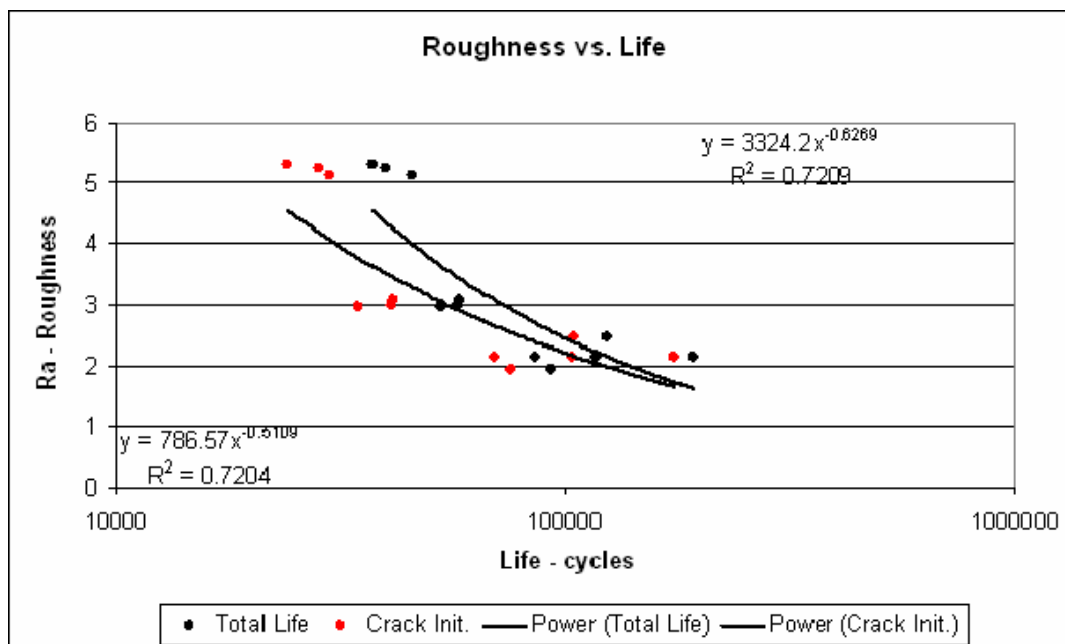
Figure 12-8 Ra versus Life for Specimens Tested at 180 ksi – Filtered Data and Power Curve Fit
